PROPOSED \$ 63.27 MILLION BOND ISSUE FOR THE IMPROVEMENT OF FIRE PROTECTION FACILITIES & SYSTEMS

**Proposed \$ 63.27 Million Bond Issue
for the Improvement of
Fire Protection Facilities & Systems**

**SAN FRANCISCO FIRE DEPARTMENT
DIVISION OF SUPPORT SERVICES
CITY AND COUNTY OF SAN FRANCISCO**

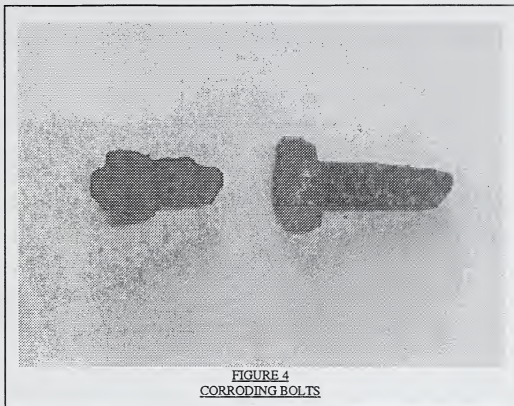
Because the Department knows that wrought iron tie-rods are very susceptible to corrosion the Fire Department switched to corrosion resistant stainless steel. When pipes have been exposed for inspection, the wrought iron tie-rods were usually severely corroded and some failed completely. Because of their number and the

critical function that they serve, tie-rod corrosion has proven to be a serious threat to the system integrity.

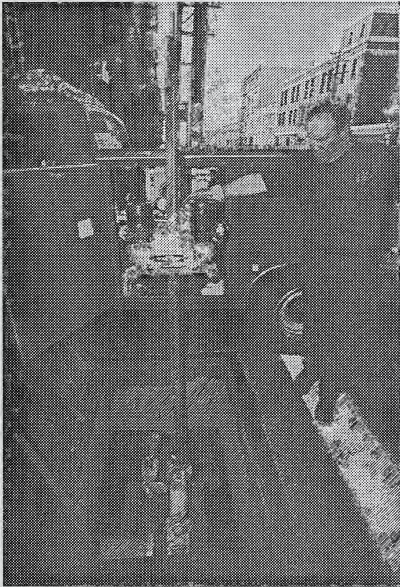
FIGURE 8
MANUAL OPERATION OF AWSS VALVE

The AWSS piping network includes numerous gate valves which can be used to regulate operating pressures and isolate damaged lines. The ability to rapidly open and close these valves is essential to provide appropriate flows and pressures and to preserve the integrity of the system in the event of a pipe failure. Historically, field crews were dispatched with truck-mounted actuators to operate the valves. This practice is time consuming and is limited by the availability of personnel and the number of valve operating apparatus, especially since the need to operate the valves always occurs when the demands upon Fire Department personnel are high.

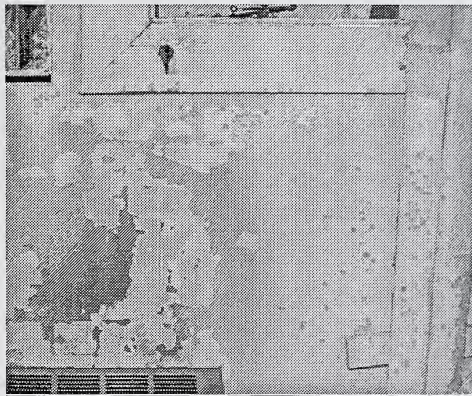
FIGURE 12
ASBESTOS AND LEAD HAZARDS

The two-story, 4,636 square foot, fireboat headquarters building includes offices, living quarters, a dormitory, and a parking bay for the fire engine stationed at the facility. The 84 year old, wood-framed building has numerous structural and architectural deficiencies. It is inadequately anchored to the pier and the framing of the first and second floors are not properly joined. In an earthquake, the building can slide up to a foot along the pier and seriously damage the structure and sever utility lines (including the gas line) that enter the house through the deck. The framing system can not withstand the lateral forces that are generated during a major earthquake.
